Technical Report CHL-97-17
August 1997

Periodic Inspection of Humboldt Bay Jetties, Eureka, California

Report 1

Base Conditions

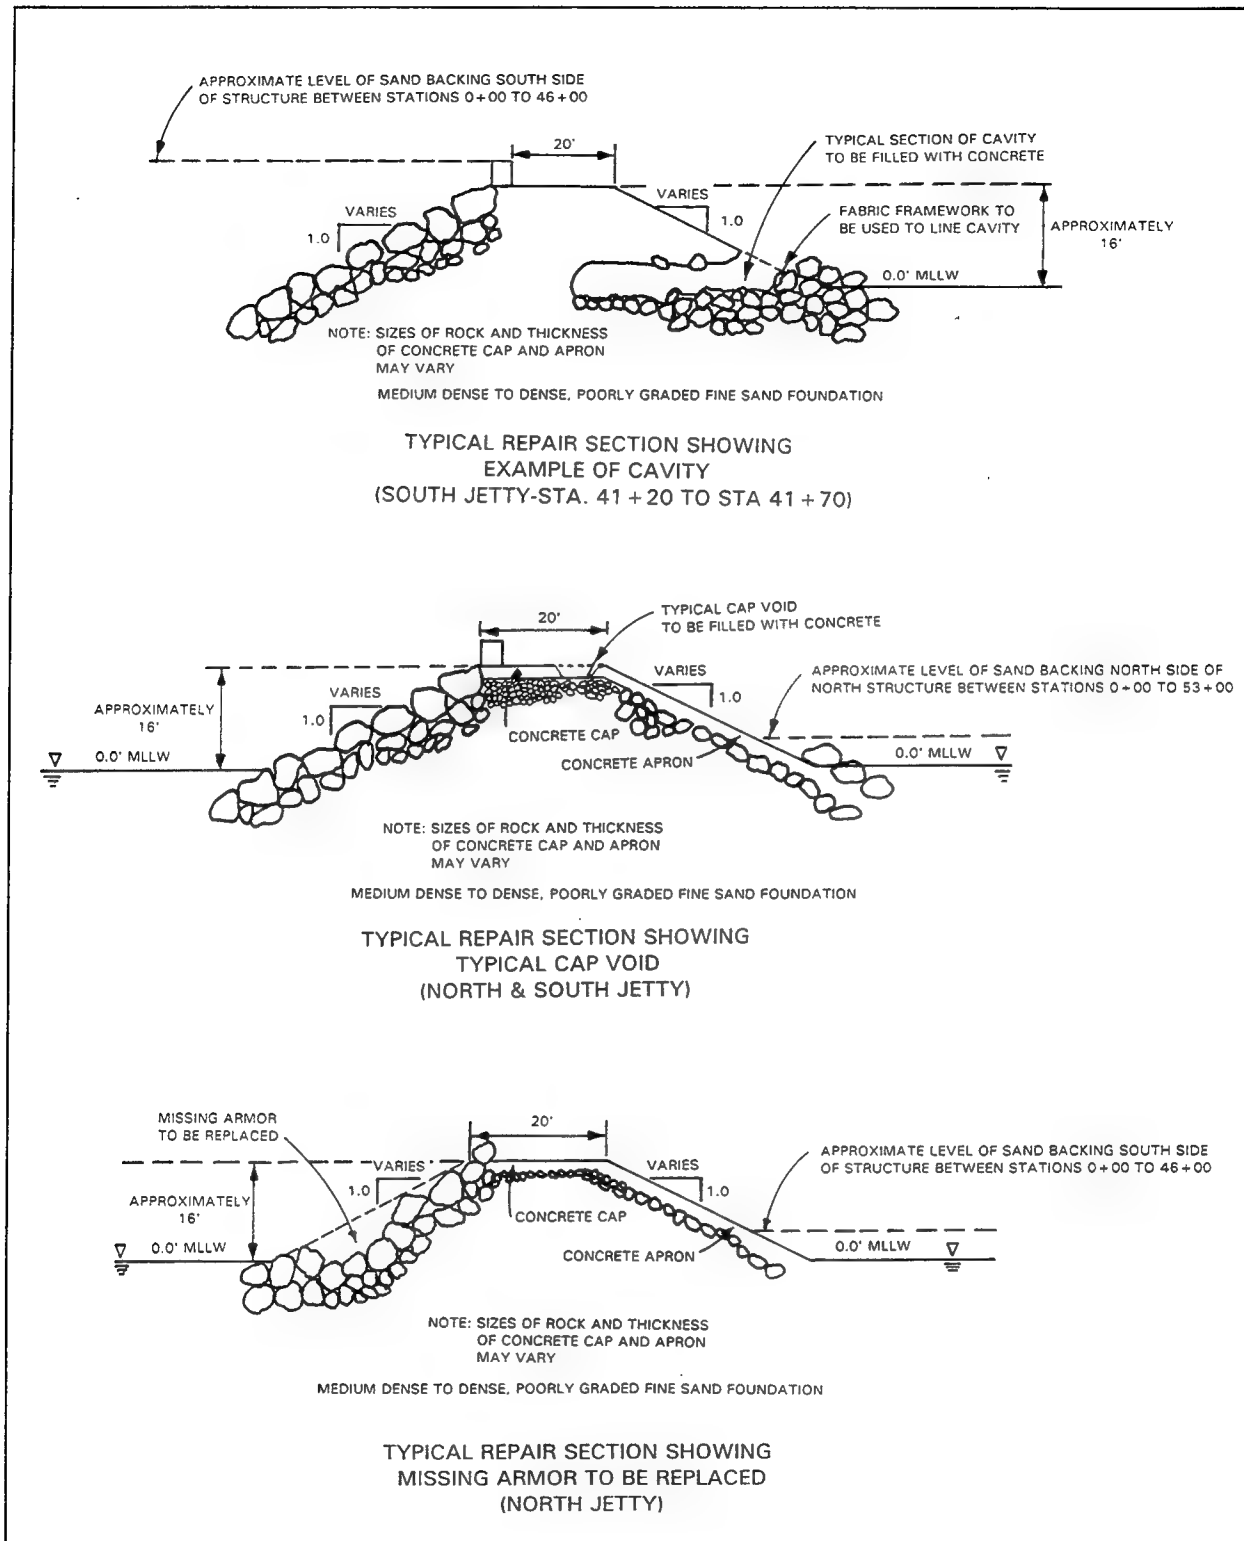
In 1988, substantial repair work was done on both of the jetties. Repairs involved the use of approximately 181,440 kg (2,000 tons) of stone for slope repair and 765 cu m (91,000 cu yd) of concrete for the filling of voids in the structure (USAED, San Francisco 1988). Figure 5 shows typical repairs made in 1988, and Figure 6 provides a plan view of Humboldt Bay, the jetty structures, and the navigation channels as of December 1994.

Figure 5. Typical repairs made to jetties in 1988

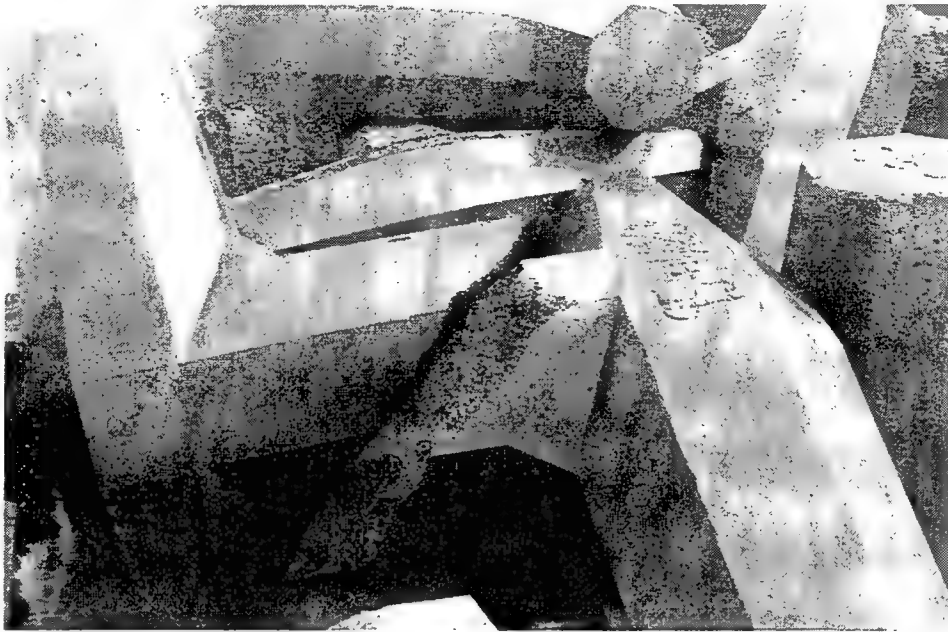
approximate center line of the structure. At the heads of the structures the baselines were projected seaward along the axis of the jetties. Thirty-four broken or cracked dolosse (seventeen on each jetty) were identified during the walking survey. Armor units with hairline cracks on one side were not counted; only those that were cracked all the way through were considered a break for recording purposes. Breaks were categorized as occurring in the shank or the fluke and as straight across or at some angle to the dolos limb. The shank is the central beam of a dolos, and the flukes are the beams on the ends of the armor unit. The broken units on the north jetty consisted of seven mid-shank breaks, eight shank-fluke breaks (shank broken in vicinity of fluke), and five fluke-shank breaks (fluke broken in vicinity of shank). One unit had two breaks. Breaks on the south jetty were characterized as follows: two units, mid-shank breaks; eight units, shank-fluke breaks; and seven units, fluke-shank breaks. Of the 35 breaks, 27 were straight breaks and 8 were angled breaks (approximately 45 deg or greater). Representative broken dolosse are shown in Figures 17-20.

Figure 17. Dolos with angled, mid-shank break

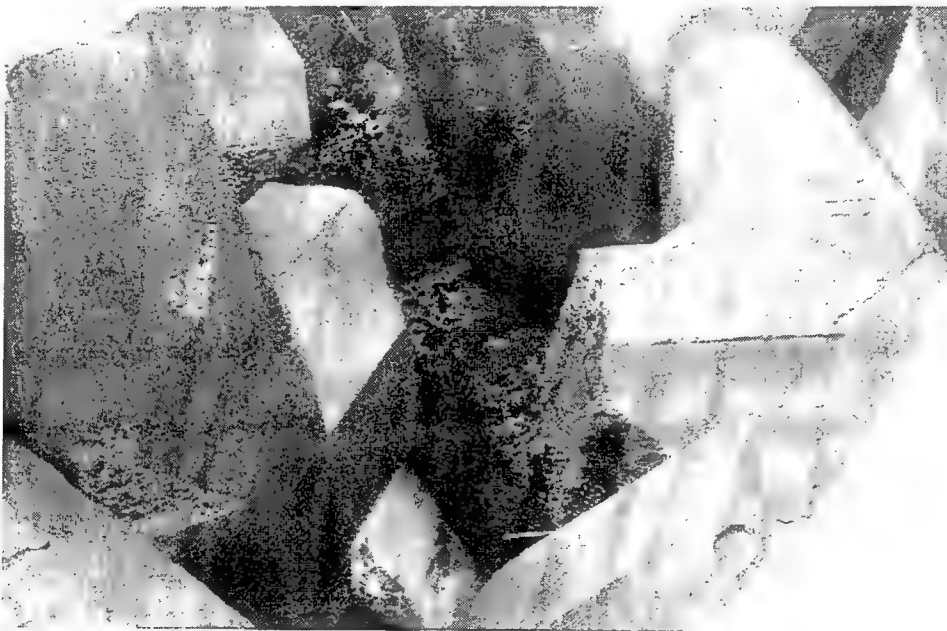
Figure 18. Dolos with straight, mid-shank break

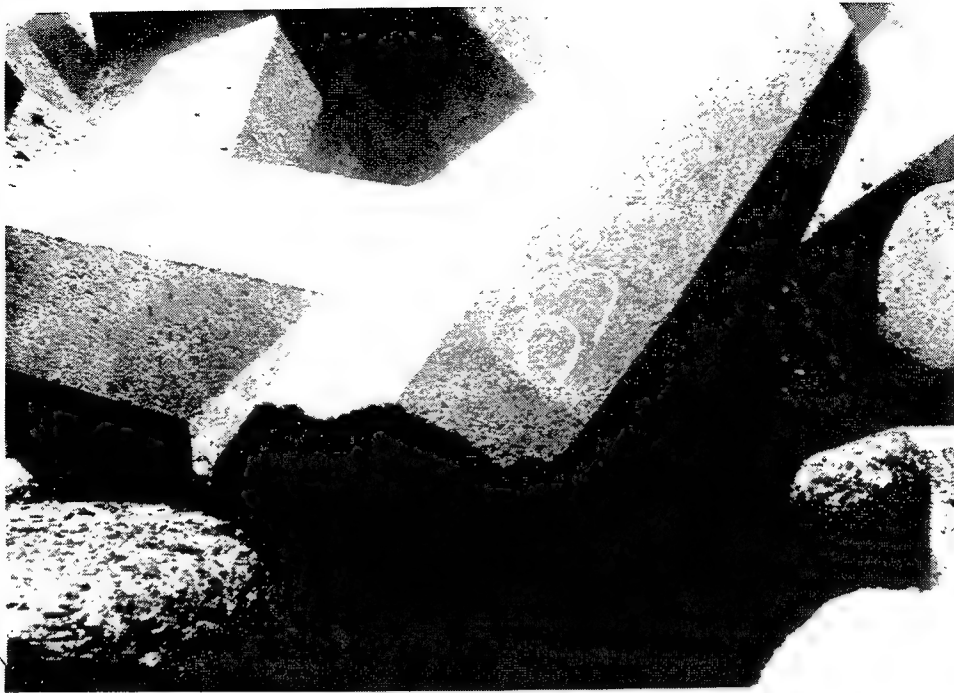
Figure 19. Dolos with straight fluke-shank break

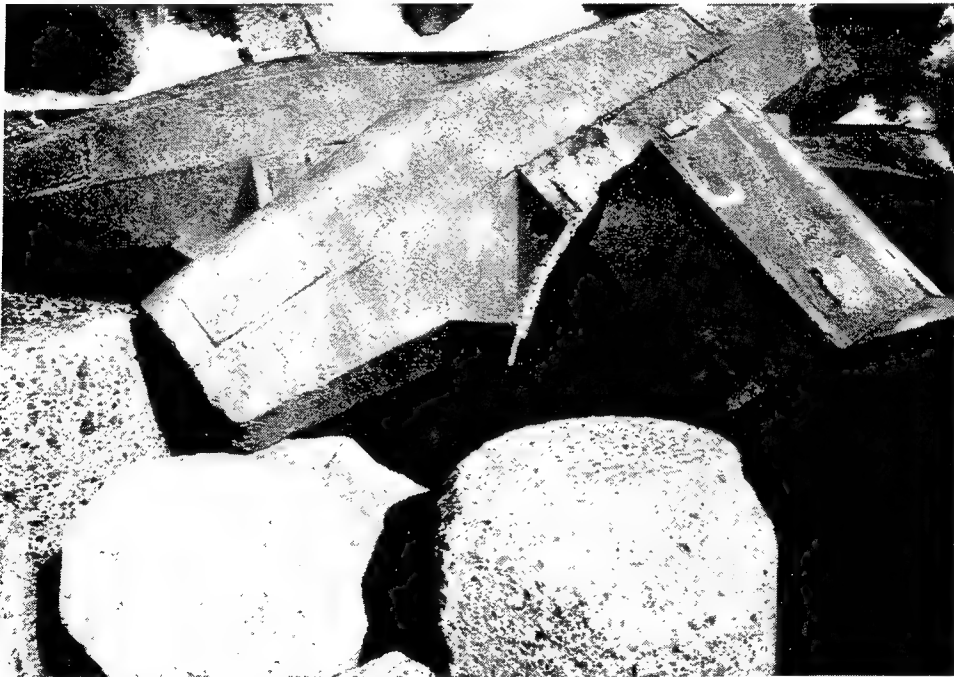
Figure 20. Dolos with straight, shank-fluke break

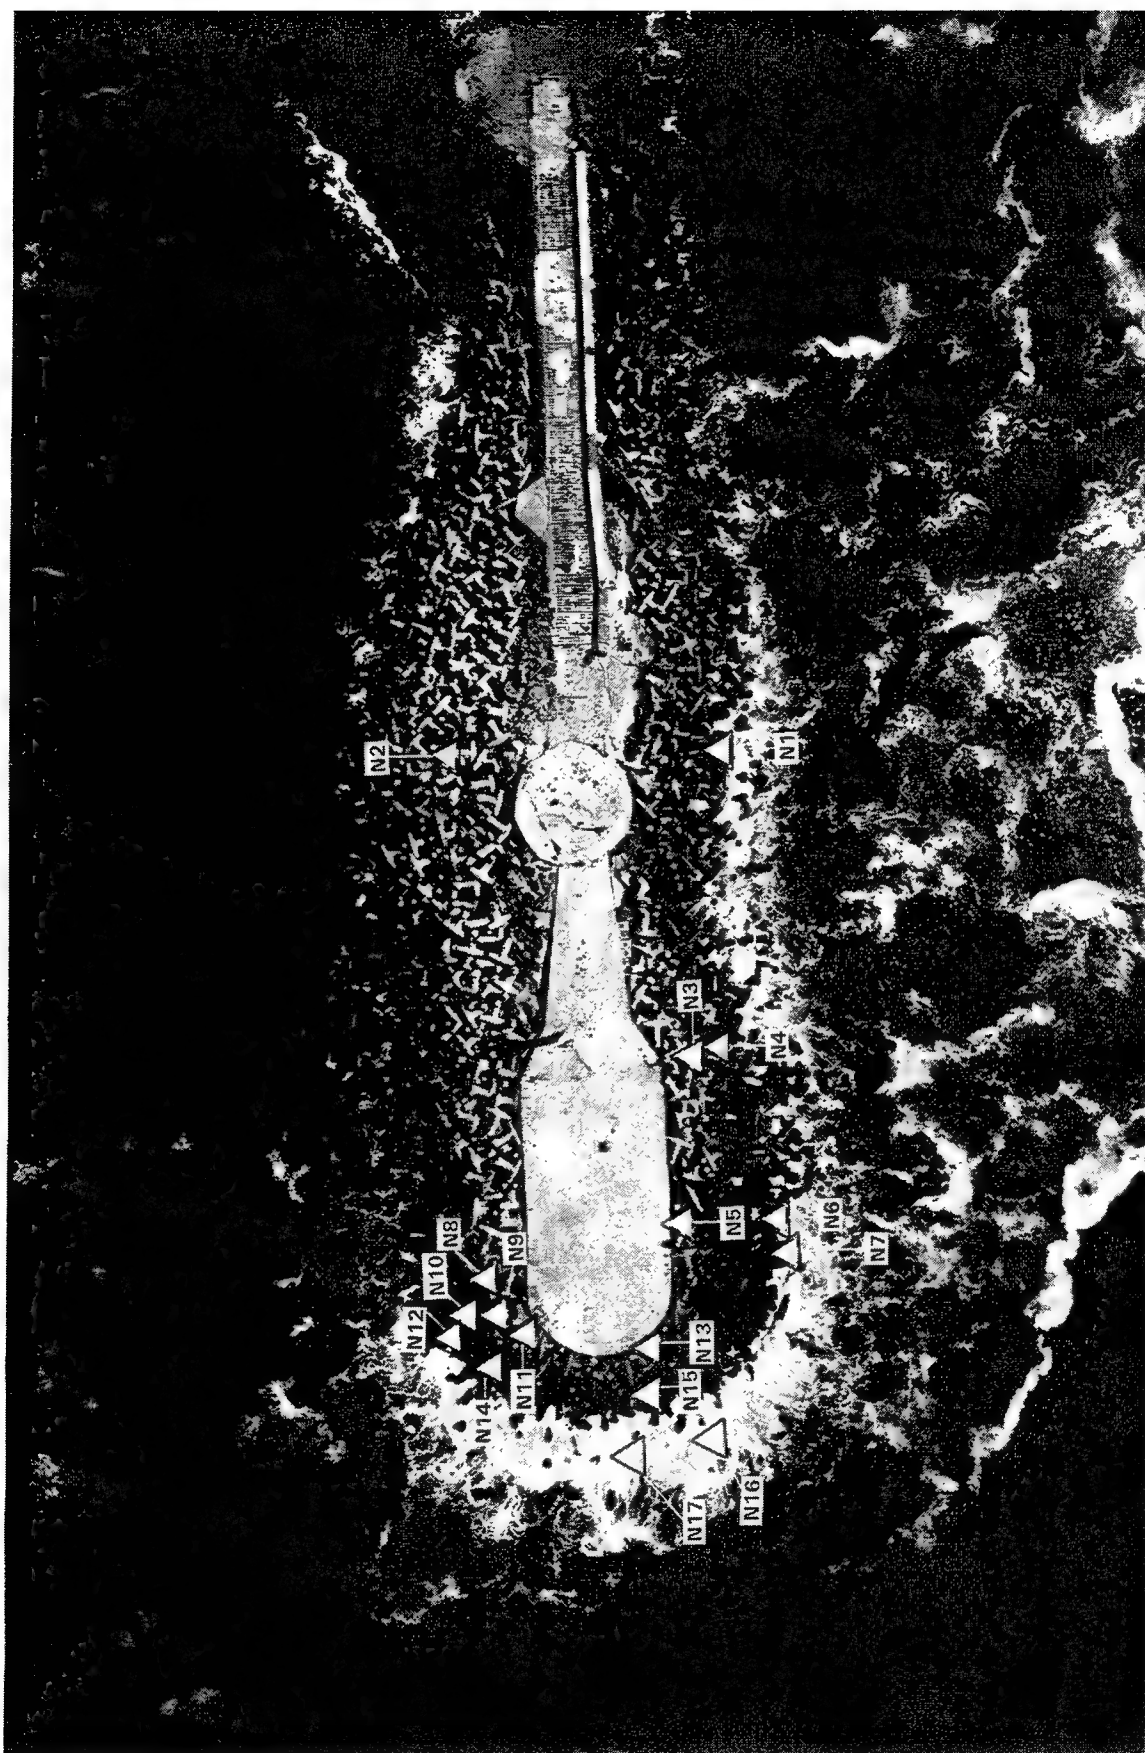
Approximate locations of the broken/cracked dolos armor units are shown in Figures 21 and 22, respectively, for the north and south jetties; and detailed data obtained during the broken armor unit inventory are shown in Table 4. Armor unit numbers identified in Figures 21 and 22 correspond to those listed in Table 4. As shown on the figures, broken units are concentrated along the seaward ends of the jetties. Eighty-eight percent of the broken units on the north jetty and seventy-one percent of those on the south jetty are located around the monolithic structures at the jetty heads. In addition, more broken dolosse were observed on the south sides of the structures than on the north. If the approximate center lines of the jetties are projected seaward along the axes of the structures, 59 percent of the broken units on the north jetty and 65 percent of those on the south jetty are located on the southern side of the jetties. With regard to distance downslope from the jetty caps, most the broken dolosse appear to be located in the active wave zone. Detailed data obtained during the broken armor unit survey will allow for an accurate indication of new breaks when the structure is revisited at some point in the future.

Figure 21. Approximate locations of broken/cracked dolos armor units on the north jetty

Armor Unit No.	Station No.	Offset from Baseline m (ft)		Type of Break, Comments
		Seaside	Channelside	
N1	71 + 17		25.30 (83)	Straight mid-shank break
N2	71 + 17	22.86 (75)		Straight mid-shank break
N3	72 + 90		18.29 (60)	Straight shank-fluke crack
N4	72 + 90		21.95 (72)	Straight mid-shank break
N5	73 + 82		14.63 (48)	Straight shank-fluke break
N6	73 + 82		32.00 (105)	Straight mid-shank break
N7	74 + 00		33.53 (110)	Angled mid-shank break
N8	74 + 10	18.29 (60)		Straight shank-fluke break
N9	74 + 30	16.76 (55)		Straight fluke-shank break
N10	74 + 30	21.34 (70)		Straight shank-fluke break
N11	74 + 40	12.19 (40)		Straight mid-shank break
N12	74 + 40	24.38 (80)		Straight fluke-shank break Angled mid-shank break
N13	74 + 55		15.24 (50)	Straight fluke-shank break
N14	74 + 65	18.29 (60)		Angled shank-fluke crack
N15	74 + 85		9.14 (30)	Straight fluke-shank break
N16	75 + 05		20.12 (66)	Straight fluke-shank break
N17	75 + 10		2.05 (10)	Straight mid-shank break

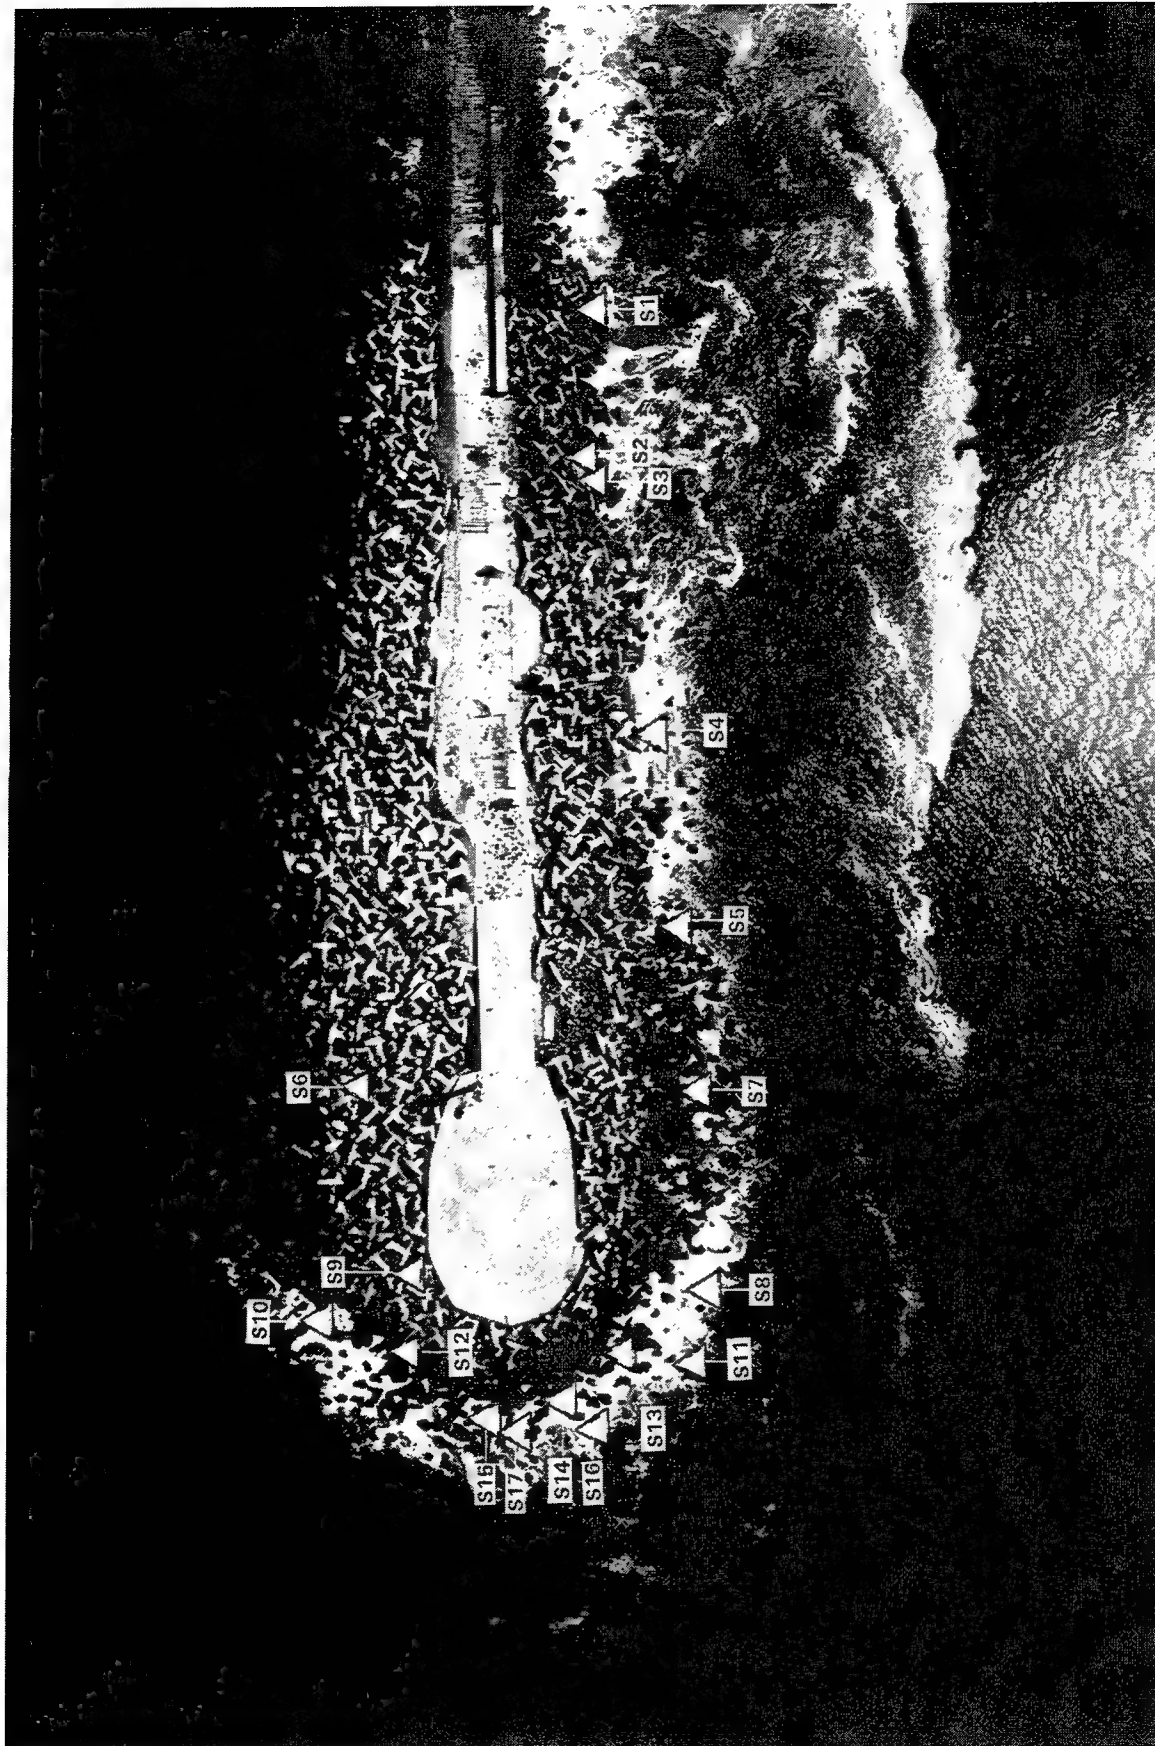
Figure 22. Approximate locations of broken/cracked dolos armor units on the south jetty

S1	84 + 59	21.95 (72)		Straight shank-fluke break
S2	85 + 36	18.29 (60)		Angled shank-fluke break
S3	85 + 45	18.29 (60)		Angled fluke-shank crack
S4	86 + 85	29.26 (96)		Angled fluke-shank crack
S5	88 + 00	31.09 (102)		Straight shank-fluke break
S6	88 + 90		25.60 (84)	Straight fluke-shank break
S7	89 + 08	34.75 (114)		Straight shank-fluke break
S8	90 + 00	36.89 (120)		Straight fluke-shank break
S9	90 + 00		15.24 (50)	Angled shank-fluke break
S10	90 + 24		33.53 (110)	Angled mid-shank break
S11	90 + 44	31.70 (104)		Straight fluke-shank break
S12	90 + 46		18.29 (60)	Straight shank-fluke break
S13	90 + 50	19.81 (65)		Straight mid-shank break
S14	90 + 70	9.14 (30)		Straight shank-fluke break
S15	90 + 80		3.05 (10)	Straight fluke-shank break
S16	90 + 84	14.02 (46)		Straight fluke-shank break
S17	100 + 90		0.61 (2)	Angled shank-fluke break
